An Analysis of Rubies with Corroded Surfaces

M.S. Krzemnicki

Swiss Gemmological Institute

This study describes corrosion features observed on a number of rubies, which had previously been set in a watch. Scanning electron microscope (SEM) analyses reveal that the corrosion is mainly controlled by crystal orientation and to a lesser extent by external factors such as the protection given by the metal mounting of the watch. Based on the observed structures, it is argued that a degreasing procedure with phosphoric acid is the most plausible cause for this corrosion damage.

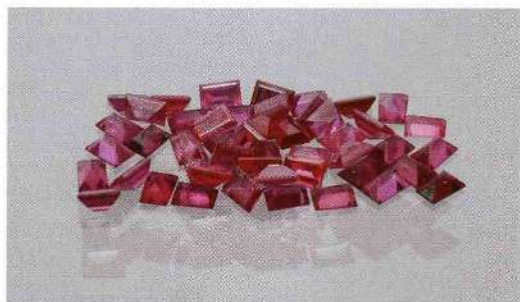
At the beginning of this year, the SSEF received a batch of 48 small rubies (Fig. 1) with etched surfaces. The stones were rectangular to trapezoid with step facets (so-called baguettes). Their size and weight was calibrated at about 0.1 ct each and about 3 mm length each. The rubies were set into the mounting of a luxury watch. According to the watch producer, these rubies were undamaged at the time they were set into the mounting. Subsequent to a galvanisation process, the quality control of the watch producer revealed that all rubies showed a rough surface, due to chemical attack. In order to understand the cause of this damage

Fig. 1 The batch of rubies with corroded surfaces, which were analysed for this study.

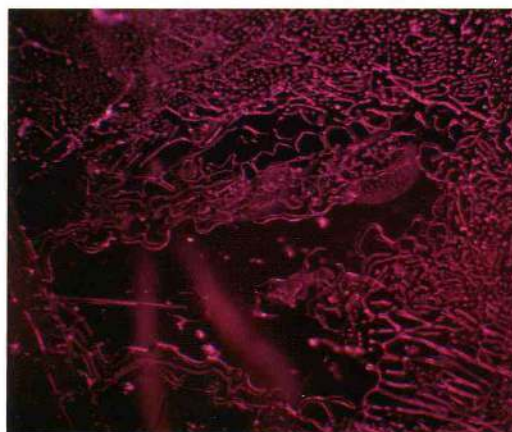
Fig. 2 Healed fissure with residues of borax flux in a pattern of irregular tubes, characteristic of rubies heated with a flux.

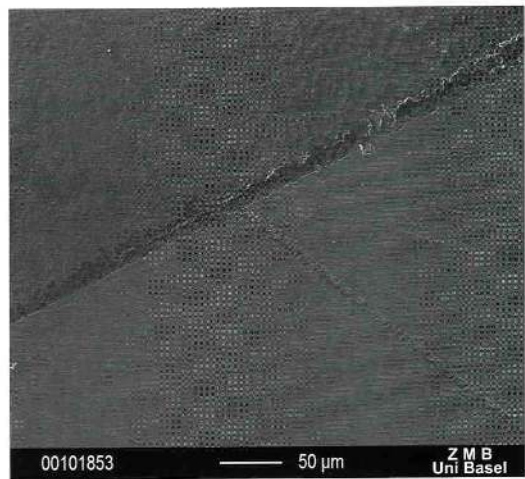
Fig. 5 SEM micrograph showing the inverse situation of a strongly etched twinning lamellae crossing a nearly unaffected facet surface. This indicates that the etching is controlled by crystallographic orientation.

The strength of the chemical etching is dependent on the orientation of the facets (or twinning lamellae) in relation to the crystallographic structure of the ruby (see Figs 3-5). The fact that the girdle of the specimen ruby does not show any etching but only polishing marks (see Fig. 7) indicates that the ruby was in the mounting when the etching occurred. The girdle was thus protected from chemical etching by the adjacent metal.

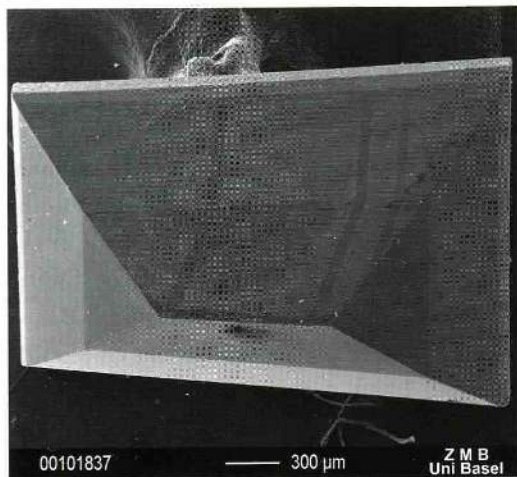
Even at low magnification the etching of the surface is evident. The SEM micrograph (Fig. 3, for magnification scale, see μm line at the bottom of the figure) of the

back (pavilion) reveals that the chemical corrosion has mainly attacked the surface on one side, and to a much lesser extent on the other facets. The bands across the facets represent twinning lamellae. These are the most striking feature, as, in this situation, they are much less affected by corrosion than is the rest of the surface. This can be seen even better under higher magnification (Fig. 4), which reveals two nearly unaffected twinning lamellae crossing the facet edges of an etched ruby. The facet at the bottom of the image (dark grey) is much more affected by the chemical corrosion than the two triangular facets (lighter grey) above. Interestingly, we may also observe the inverse situation: a twinning lamella, which is affected by corrosion and which crosses a nearly unaffected facet surface (Fig. 5). Although opposite in etching effect to figures 3 and 4, its cause is the same, i.e. a chemical etching process controlled by crystallographic orientation.

Fig. 3 SEM micrograph of the pavilion of one ruby sample. The surface shows etch marks and less corroded twinning lamellae bands.

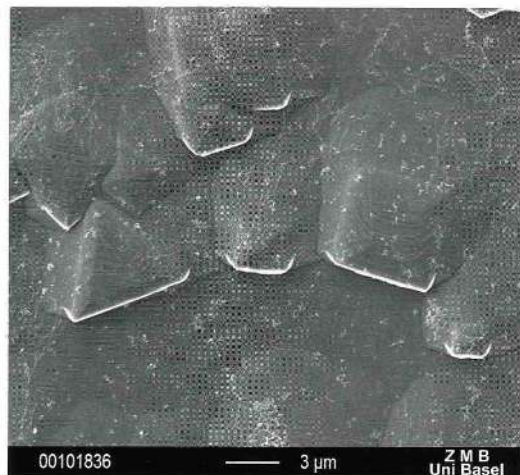
At high magnification (Fig. 6), we observe that the corrosion results in a geometric (triangular) etching pattern, which is controlled by the crystal structure of the trigonal corundum. The fine lines on the pattern represent the original growth zoning of the natural ruby crystal. Only due to the chemical etching has this fine structure become visible.

Fig. 6 SEM micrograph at high magnification showing geometric etching patterns and fine lines due to primary growth zoning.

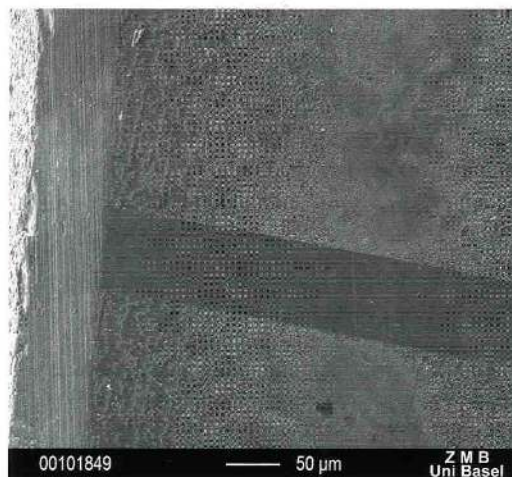
Fig. 7 SEM micrograph showing the girdle of a ruby sample with corrosion marks only on the pavilion facet (crossed by an unaffected twinning layer). The girdle was protected from corrosion by the metal mounting.

understand why corrosion occurred, we have to know that phosphoric acid can be used as a degreasing agent prior to a galvanisation process (e.g. Van Ooij & Vijayan, US Patent 6'200'636 B1, March 2001). Although we were not given details of the specific galvanisation procedure in this case, we assume that a strong acid, such as phosphoric acid, was used, presumably to clean the metal mounting, just prior to galvanisation of the metal mounting and it was this that corroded the surface of the rubies. To re-establish the previous lustre and surface condition, these rubies would have to be re-polished.
