DAMAGETO CUT GEMSTONES

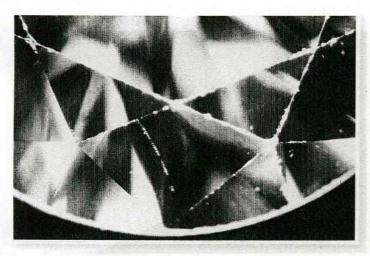
Diamond has a high scratch hardness, but is very sensitive to percussion and pressure in the situation of daily wear. Because knocking and rubbing with other diamonds, facet edges and corners can appear white after lengthy periods of wear. (Fig. 1). Sharp-edged or thin girdles on diamonds are prone to damage as they will chip during setting or later. (Fig. 2).

FIG. 1: WORN EDGES AND CORNERS ON A BRILLIANT CUT DIAMOND, WITH A SCRATCH ACROSS A MAIN FACET. DIAMONDS ARE NOT INDESTRUCTIBLE BUT QUITE SENSITIVE TO KNOCKS AND CONTACT WITH OTHER DIAMONDS.

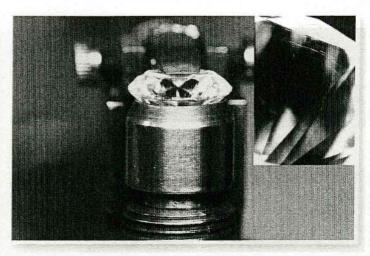
Rough usage of diamond cutting tools may also have created pressure or knocking fissures in the cutting factory. Numerous diamonds leave the factory with small percussion marks (fissures) and scratches due to careless dopping procedures during the cutting process (Fig. 3 & Fig. 4).

FIG. 3: DIAMOND PARTICLES UNDER THE METAL CLAMP CAUSE SCRATCHES WHEN THE STONE IS TURNED IN THE DOP FOR CROWN FACET CUTTING. SUCH SCRATCHES MAY BE VISIBLE AT 10X AND AVOID A LOUPE CLEAN PURITY GRADE.

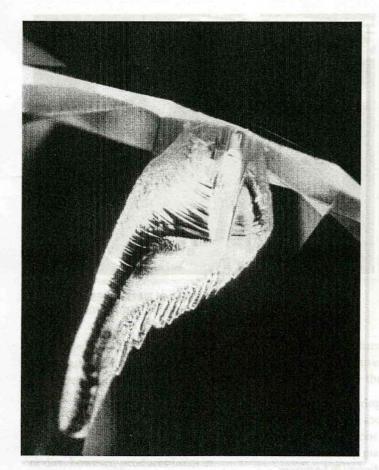
FIG. 2: CHIP ON THE GIRDLE OF A BRILLIANT CUT DIAMOND, SITUATED ON AN AREA WHERE THE GIRDLE IS THIN. THIN OR SHARP EDGED GIRDLES ARE POTENTIAL DAMAGE ZONES.

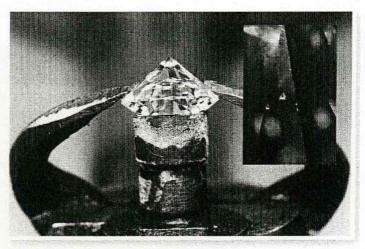
FIG. 4: FORCED CLOSING OF THE CLAWS OF THE DOP FOR PAVILION FACET CUTTING MAY CAUSE PRESSURE MARKS, SUCH FISSURES MAY BE VISIBLE AT 10X AND AVOID A LOUPE CLEAN PURITY GRADE.

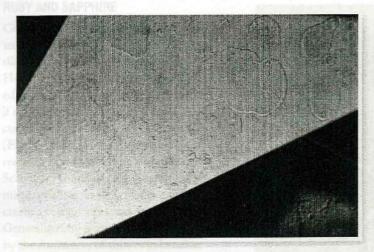
A burned surface is another type of damage which may occur during the cutting process. The heat produced by the friction on the lap allows carbon atoms from the diamond surface to react with oxygen from the air and form volatile carbon dioxide CO₂. This gas forms at the expense of the diamond surface that is subsequently corroded and shows whitish burn marks. (Fig. 5). Boric acid is usually used to cool the diamond on the dop and coat it with an air-proof flux layer, that inhibits the corrosion.

FIG. 5: BURNED SURFACE SPOTS (BURN MARKS) ON A STAR FACET OF A BRILLIANT CUT DIAMOND. MAGN. 30X.

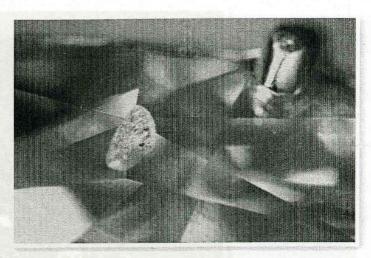
FIG. 7: A STEPPED CHIP ON A CUT DIAMOND, CAUSED BY A LASER SHOT. IN THE CENTRE OF THE CRATER A BLACK PORTION OF GRAPHITE IS VISIBLE.

Although soldering with a laser does not heat up the mounting or the stone, special precautions also must be taken. Laser soldering may be dangerous for mounted diamonds since the energy of a laser shot may transform diamond into graphite. Either directly shot into the diamond or by reflection on the polished

metal, the concentrated energy can, in a very short time transform diamond into graphite. Graphite has a less dense atomic structure, and a transformation from diamond to graphite increases the processed area by 1.6x. If such a phase transition is close under the surface of a diamond, the pressure will burst that spot and a crater will be formed (Fig. 7). Shielding the stone's surface with black ink would be good protection against such unexpected damage (Hänni, 2006).

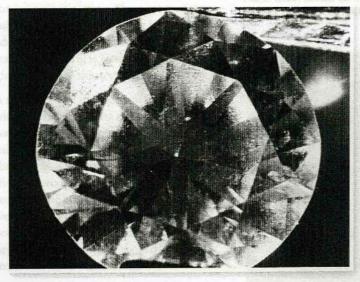
FIG. 6: A SOLDERING REPAIR OF A RING WITH THIS 0.30 CT BRILLIANT LEFT THE STONE WITH A TOTALLY BURNED SURFACE.

The flame of a torch is hot enough to allow the diamond to form CO₂ in the presence of air. A simple remedy against this corrosion is the application of a coating: a borax or boric acid layer protects the diamond and prevents oxygen reaching the surface. Any fat or dirt, however, produces holes in this layer, and corrosion can take place (Fig. 6). Therefore rings etc. must be thoroughly cleaned before soldering.

Surfaces of all diamonds must be coated with the protective borax layer when a ring goes under the torch.

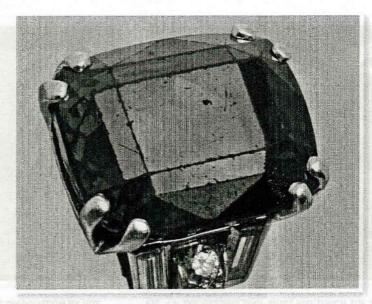
Corundum is a remarkably tough ring stone and tends to chip much less than diamond with its perfect cleavage. However, wear marks, like rubbed edges and corners, must be expected if ring stones are worn on a hand continually over a long period of time (Fig. 8). Parting along twin planes is a reaction akin to cleavage and may occur. Secondary minerals (e.g. boehmite) may crystallise on twin planes and create a certain weakness in corundum. Generally ruby is much more affected by the formation of thin twin lamellae than sapphire. This also often lessens the transparency of ruby and represents a source of damage when force is applied, for example in setting. Since most of the rubies in the marketplace are heated with additives such as borax, such weakness in respect of parting is lessened due to the gluing effect of this treatment.

FIG. 8: WEAR MARKS ON A SAPPHIRE MOUNTED IN A RING, WITH ABRASIONS ON FACETS, CORNERS AND EDGES.

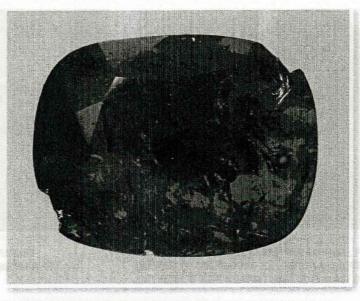
A severe case of damage was encountered with an unheated ruby of over 10 ct that was removed from its setting, and re-set using an inappropriate tool for closing the setting. The cushion shaped stone showed two serious chips on opposite corners. The author assumes that tongs were used to bring the claws back in position. Since they reacted to some degree, more force was applied, and the stone shattered within. (Fig. 9).

FIG. 9: A RUBY WITH NUMEROUS TWIN LAMELLAE AND NATURAL FISSURES DAMAGED IN AN ATTEMPT TO RE-SET THE STONE WITH TOO MUCH PRESSURE.

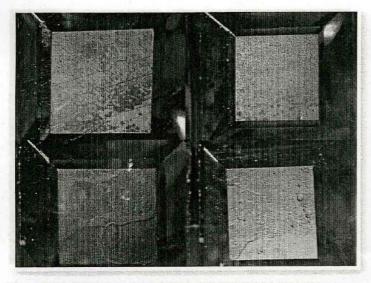
FIG. 10: RUBIES WITH CORRODED SURFACES DUE TO DISSOLUTION BY HOT SOLDERING FLUX.

Using torch soldering on rings incorporating ruby or sapphire can present a problem for the stone despite its usually good reaction to heat. In contrast to diamond, any borax should be kept away from stones when they remain in a setting for soldering. Hot borax melt is a solvent for most minerals and corundum gets heavily etched from such melt. Corrosions can only disappear after a re-polishing of the stone (Fig. 10).

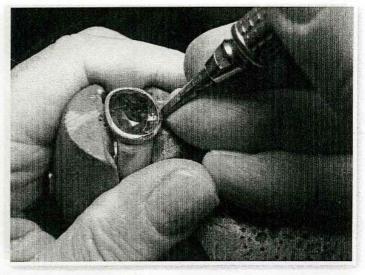
FIG. 12: THE SETTING TOOL MUST NOT TOUCH THE STONE WHICH IS LOGICAL, BUT DAMAGED STONES QUITE OFTEN HAPPEN WITH THIS TYPE OF BLEMISH.

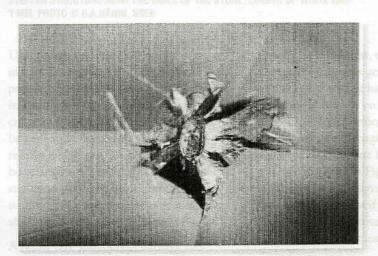
FIG. 11: AN INCLUSION OF ZIRCON WITH TRACES OF URANIUM INCREASE IN SAPPHIRE, WITH TENSION FRACTURES AND BLOW-OFF TOWARDS THE SURFACE. MAGN. 25X.

A rather rare situation of damage can be seen in corundum when radioactive included minerals are close to surface. The decay of uranium or thorium in zircon, uraninite or thorianite as an example, increases the volume of such inclusions. This creates stress into the neighbouring host mineral and leads to fractures emanating from the inclusion. When such grains are close to the surface, the tension may blast the overlaying corundum, as seen in Fig. 11. Despite its toughness, corundum is often damaged by careless gemstone setters who support their setting hammer on the stone instead of on the metal only (Fig. 12). Closed settings often mask such injuries and the damage usually becomes visible when the stone is unset. A typical example is shown in Fig. 13, where the sapphire released a significant chip after the stone was removed from the setting. Re-shaping the contour of the stone means an important loss of weight.

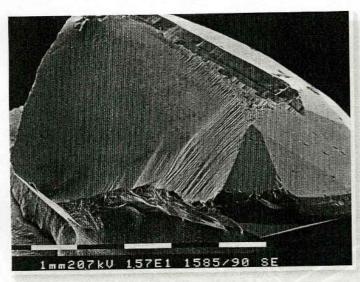
FIG. 14: SEM PICTURE SHOWING THE BREAK STRUCTURE OF A SAPPHIRE DAMAGED DURING ENLARGEMENT OF A RING. THE FORCE TO BREAK THE STONE COMES FROM THE CULET AND AFTER A CONCHOIDAL BREAK IT ENDS IN A STEPPED STRUCTURE NEAR THE TABLE OF THE STONE. LENGTH OF WHITE BAR 1 MM. PHOTO © H.A.HÄNNI, SSEF.

Stones that are deeper than the ring head can cause accidents especially if, on the sizing mandrel the culet touches the metal, subsequent hammering can cause the stone to break. A sizing stick with a groove is highly recommended to escape damage (Fig. 14).

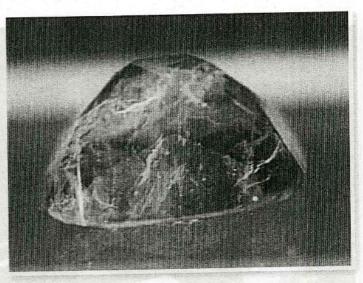
FIG. 15: FISSURE FILLED EMERALD SEEN IN LONG WAVE ULTRAVIOLET ILLUMINATION. THE EXTENDED NETWORK OF BRIGHT LINES SHOWS A SIGNIFICANT DEGREE OF TREATMENT. THE WHITISH FLUORESCENCE OF THE FILLER IS TYPICAL FOR EPOXY RESIN. LENGTH OF THE STONE APPROX. 12 MM.

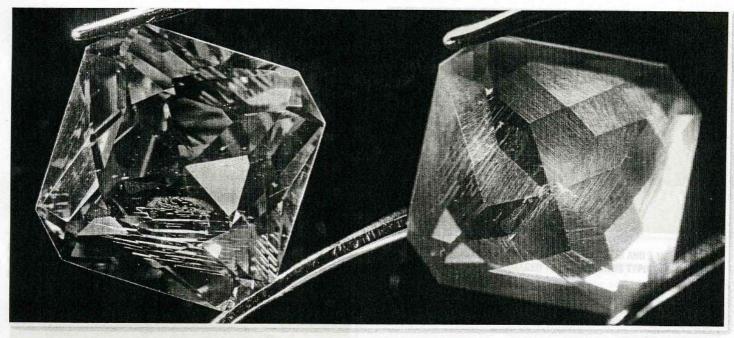
FIG. 16: THE WARM ACID BATH USED AFTER REPAIR SOLDERING ATTACKED THE SURFACE OF PERIDOT. DISTINCT CORROSION IS VISIBLE AFTER 20 MINUTES, MAKING THE SURFACE BLURRED. LEFT SIDE ORIGINAL PERIDOT, RIGHT SIDE AFTER 20 MINUTES IN PICKLING SOLUTION.

When a peridot was sent for analysis of the loss of lustre, the first thought was that the poor polish was disguised with surface waxing or oiling. The client, a goldsmith who bought the peridot from a cutter then polished the stone himself, advised that he had just cleaned a ring after having set the stone. The first thought was that the polish was made by using poorly graded diamond powder, but a reference peridot from the same cutter showed a perfect polish. After some questioning about the method of cleaning the goldsmith mentioned the bath in the pickling solution. A short experiment disclosed evidence that the said solution was able to attack the

surface of olivine, a new experience for a gemmologist, but maybe an old fact for an experienced goldsmith. Fig. 16 shows the reference peridot before and after the bath in hot pickling solution composed of sulphuric acid and nitric acid, as it is commonly used in jewellery workshops.

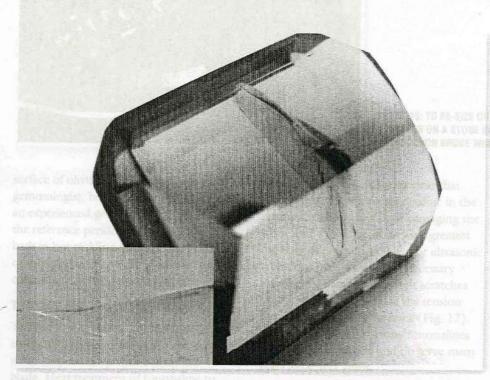
FIG. 17: A TINY SCRATCH (LEFT ON INSET) ON THE SURFACE OF THIS TOURMALINE HAS RELEASED A MAJOR FISSURE.

the slightest stress. It seems clear that soldering a ring with a tourmaline in the setting increases the risk of damaging the stone and should be done with greatest measure of precaution. Heat or ultrasonic vibrations may provide the necessary impulse for damage. Slightest scratches on the surface may release the tension that causes the stone to crack (Fig. 17). However and luckily, many tourmalines are not under tension and do serve many years as perfect gems.

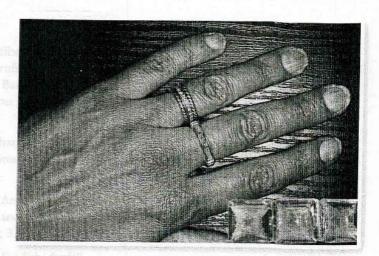
FIG. 20: FRICTION BETWEEN A DIAMOND ETERNITY RING AND A HESSONITE CHANNEL-SET RING BADLY DAMAGED THE RING OF THIS TYPIST.

Hessonite garnets, being coarsely polycrystalline in their composition possess a quite rough fracture. Intense wear will break off the individual crystallites and the surface will look worse than just rubbed. When a typist presented her ring that she had purchased only 5 weeks previously, she wanted to accuse the jeweller for selling her fake stones. In fact the hessonites were natural gemstones but her new ring was being worn next to a diamond eternity ring. Her daily typing movements caused the diamonds to inflict damage to the hessonites as shown in Fig. 20.

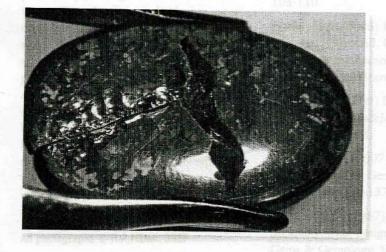
FIG. 19: TO RE-SIZE OR DEFORM A RING MAY PUT CONSIDERABLE STRESS ON A STONE IN A CLOSED SETTING. THIS FLAT BLACK OPAL CABOCHON BROKE WHEN THE GOLDSMITH RE-ADJUSTED THE RING.

Opals are among the more sensitive gemstones. Drying out is said to be the reason for their reported weakness. Some opals become fractured and show a web-like network of fine fissures. It goes without saying that a flat stone in a bezel setting would probably not survive the re-sizing of a ring because of the tension induced on the mounting. Fig. 19 shows how a flat opal cabochon reacted on the slight deformation of the bezel setting.
