Damage caused to Gemstones by Lasers during Jewellery Repair

珠寶維修期間 激光對寶石造成的損壞

M.S. Krzemnicki¹, L. Kiefert^{2,3} & K. Schollenbruch²

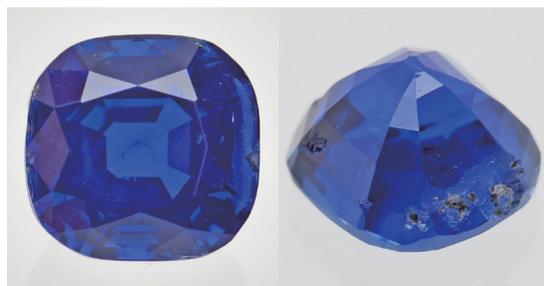
Recently, several gem labs have observed damage to coloured gemstones caused by a repair laser (SSEF, 2019; Kiefert & Schollenbruch, 2019). Some of this damage has occurred on high-value gemstones such as Kashmir sapphires (Fig. 1) and Burmese (Myanmar sapphires), East African and Thai rubies. If these gems have to be repolished due to such damage, they lose considerable weight and therefore value.

Fig. 1 Kashmir sapphire of 5.11 cts (table and pavilion side) submitted by a client showing several deep areas of laser damage along the girdle and on the pavilion, even visible with the naked eye through the crown.

re-cutting of such a damaged gemstone may result in a substantial loss of weight. This is especially worrisome in the case of a high-value gemstone, such as the 5 ct Kashmir sapphire presented in Fig. 1.

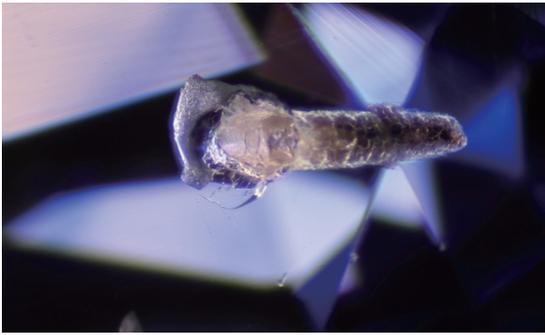
The first sapphire that was tested while hand-held produced a surprising result. The damage appeared on the opposite side of the laser focus in a cone-shaped tube (Fig. 4). A secondary area of damage was recorded at a random location which was also located on the opposite side of the stone.

Fig. 4 This cone-shaped tube was caused by a laser focused on the surface opposite the area of damage.
Photo: K. Schollenbruch, GGL.

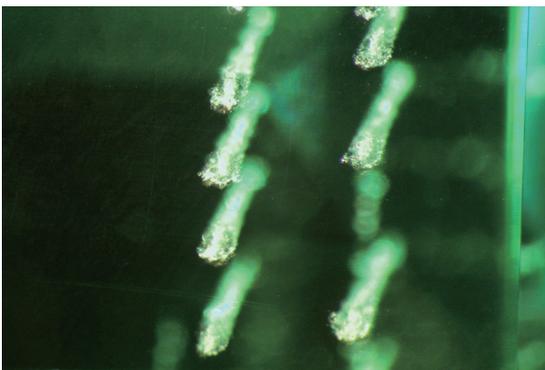
Apart from the energy, the pulse, the focus of the laser beam and the backing of the mineral, it seemed that the number of inclusions and the size of the stone also affected the final result. The more fractures that were observed in a stone the shallower the impact was of the laser beam. On stones without fractures the laser left distinct traces which could be used to identify laser damage (Fig. 5).

Fig. 5 Series of cone-shaped areas of damage created by a laser (1064 nm emission) in an inclusion-free synthetic green corundum. *Photo: M.S. Krzemnicki, SSEF*
 由激光（1064 nm 放射）在不含內含物的合成綠色剛玉中造成的一連串錐形的損傷。

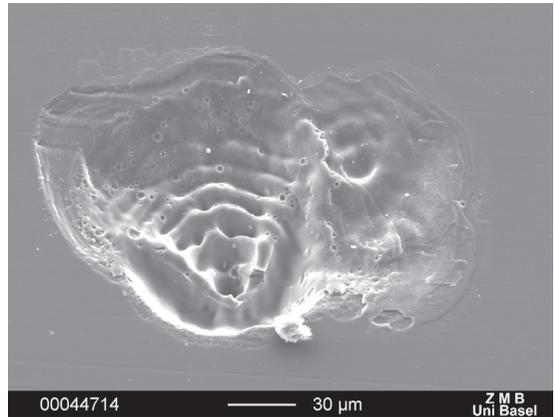
In most cases a shallow to cone-shaped cavity was observed. Often this cavity was either filled or coated with a glassy substance (Fig. 6) resulting from the local melting of the gemstone due to the

laser. In some cases, this feature might visually resemble a cavity filled with “aged” resin or lacquer.

Fig. 6 SEM micrograph (high magnification) of a sapphire surface showing a cone-shaped area of laser damage with deposition of molten material as a glassy residue in the cavity created. *Photo: M.S. Krzemnicki, SSEF and University of Basel.*

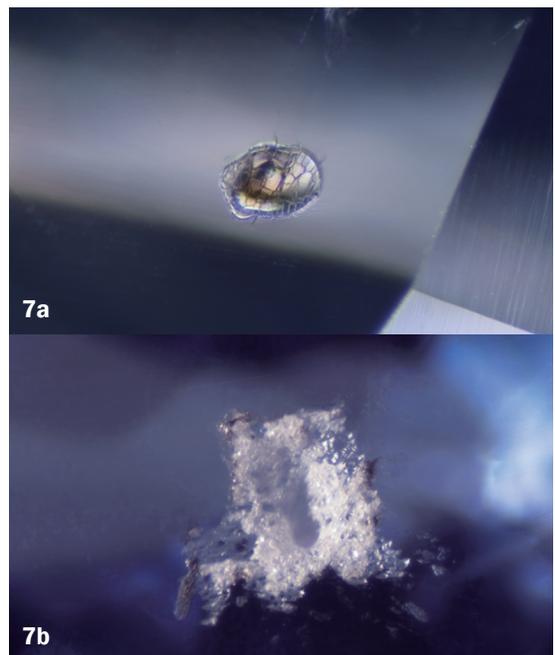
The glassy substance observed in these laser holes often shows a brownish colour and is pervaded by small fissures (crackling) as a result of fast cooling (Fig. 7a), but in some cases it may also have a whitish, foamy appearance due to numerous small microcracks and tiny inclusions (Fig. 7b).

Fig. 7 a) laser spot with brownish glassy crust – cracked. b) whitish, foamy glass residue around the laser hole.
Photos: K. Schollenbruch, GGL.

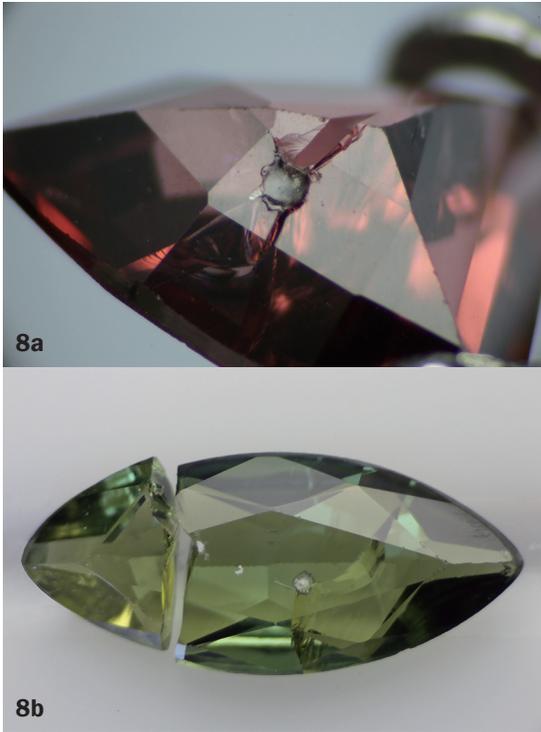
In many cases small chips are splintered from the surface around the hole. In some of the samples, the tension caused during laser treatment lead to the formation of numerous cracks around the laser hole (Fig. 1) or even forced the stone to break as shown in Fig. 8a and 8b.

Fig. 8 a) Laser-induced damage on a garnet.
b) This inclusion-free tourmaline broke after the laser hit its surface (The white spot in the centre of the sample was caused by another laser impulse with less energy).

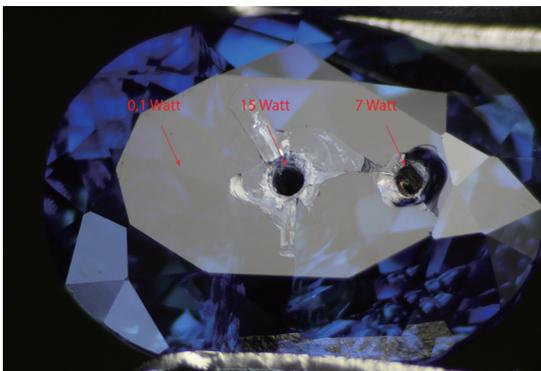
Fig. 9 Experiment using three different laser energies (0.1, 7 and 15 Watt). *Photo: K. Schollenbruch, GGL.*

To assess the relationship between laser energy and resulting damage, we used a synthetic sapphire which was hit by a single laser shot on three positions, each with a different laser energy (0.1 W, 15 W, 7 W). As expected, the strongest impact and greatest laser damage occurred when the highest laser power was applied (Fig. 9). The laser shot at 0.1 W energy did not leave any traces on the stone. The 15 W shot created a hole that went right through the synthetic sapphire. Simultaneously, numerous and extensive fractures were created around the laser hole but only very little glassy substance was found. The laser shot at 7 W created a deep cone-shaped cavity (about half the depth of the stone) with some cracking around the drill hole, but notably also considerable brownish glassy residue (from the local melting of the synthetic sapphire) in and around the laser hole.

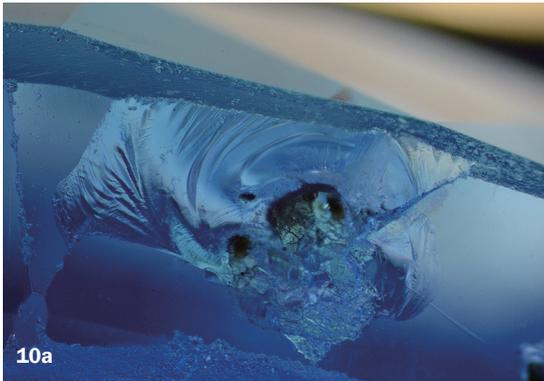
10a

As mentioned before, the starting point for this experimental study was that the authors had recently come across a number of cases in which the sort of laser damage discussed above were observed on stones submitted to the Swiss Gemmological Institute SSEF and Gubelin Gem Lab by clients for gem testing. Some of this laser damage was even visible to the naked eye. All were found either on the pavilion or at the girdle (Fig. 10 a-c) in next page.

The laser damage encountered in clients' stones is often close to the girdle, in positions where there might previously have been a prong setting . When doing repair work on these prongs, the laser probably hit the stone causing the damage, either on the side of the repair area, opposite the repair area, or in more than one random spot. So, despite claims that laser repair does not cause damage to gemstones, the jeweller must make sure not to hit the stone accidentally. In addition, the power of the laser beam also has a great influence on the damage caused.

Fig. 10 Three stones of high commercial value showing laser damage very similar to those obtained on our samples using a jewellery repair laser. (10a: sapphire from Kashmir, 10b: ruby from Madagascar, 10c: ruby from Mozambique). Photos: M.S. Krzemnicki, SSEF and K.Schollenbruch, GGL 三顆具有高商業價值的寶石顯示的激光損傷與我們使用珠寶修復激光在樣品上獲得的損傷非常相似。(10a: 克什米爾藍寶石, 10b: 馬達加斯加紅寶石, 10c: 莫桑比克紅寶石)。

To summarise, damage caused by a jewellery repair laser can be a real problem for the jeweller. It is, though, a dilemma which could be easily avoided either by not using such laser equipment for jewellery repair, or by having laser repairs carried out only by highly experienced staff.
