Damage caused to Gemstones by Lasers during Jewellery Repair

珠寶維修期間 激光對寶石造成的損壞

M.S. Krzemnicki¹, L. Kiefert^{2,3} & K. Schollenbruch²

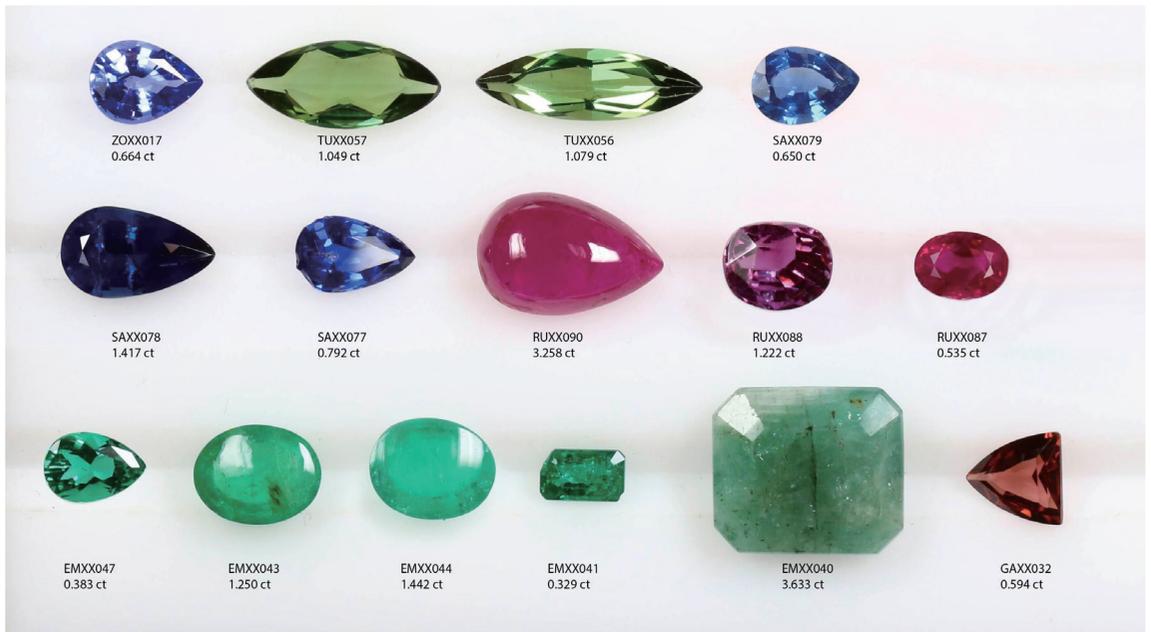
Fig.2 These gemstones were tested with the jewellery repair laser: from top left to bottom right: one tanzanite, two green tourmalines, three sapphires, three rubies, five emeralds and one garnet. *Photo: K. Schollenbruch, GGL.*
 這些寶石使用珠寶修復激光進行了測試：從左上到右下：一顆坦桑石、兩顆綠色碧璽、三顆藍寶石、三顆紅寶石、五顆祖母綠和一顆石榴石。

16 gemstones were selected for this study to cover different mineral species as well as different clarity grades in order to evaluate the effect of the laser on these gems. Fig. 2 gives an overview of the tested gemstones (sapphire, ruby, emerald, garnet, tourmaline, and tanzanite).

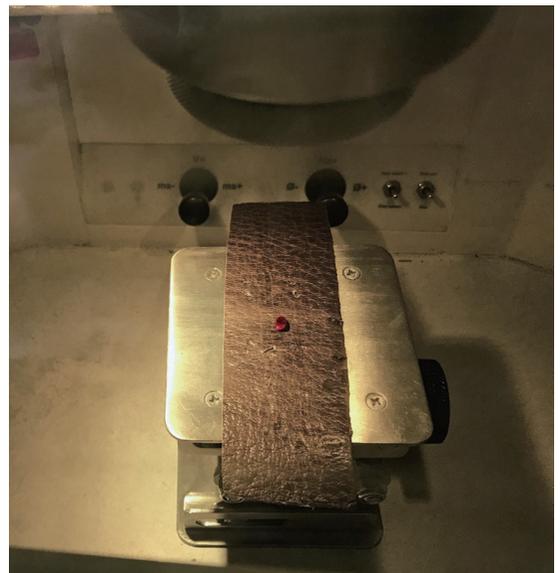
Although jewellery pieces are usually handheld during soldering and the laser is focused free hand on the surface, in most cases we used a metal block (adjustable in height) on which the gemstone could rest instead. This sample holder was covered with a leather pad in order to avoid reflections from the metallic surface (Fig. 3).

The gemstones were tested using various energy settings with and without the leather pad as well as hand-held to see if the results varied. Standard setup was on a metal block with a leather pad (Fig. 3) with the laser focused on the surface of the pavilion.

Fig. 3 Interior of the Alpha Laser A50 chamber. The stone is positioned on a metal block covered with a leather pad to avoid reflection of the laser on the metallic surface.
